NATF(SI) REPORT OF TEST RESULTS
NATF(SI) 13800/16 (3/67)

REPORT NO: NATF(SI)-R2
DATE: 16 May 1967

Shipboard arresting-gear fleet support; Mark 7 arresting-system
improvement support (epoxy-poured terminals)

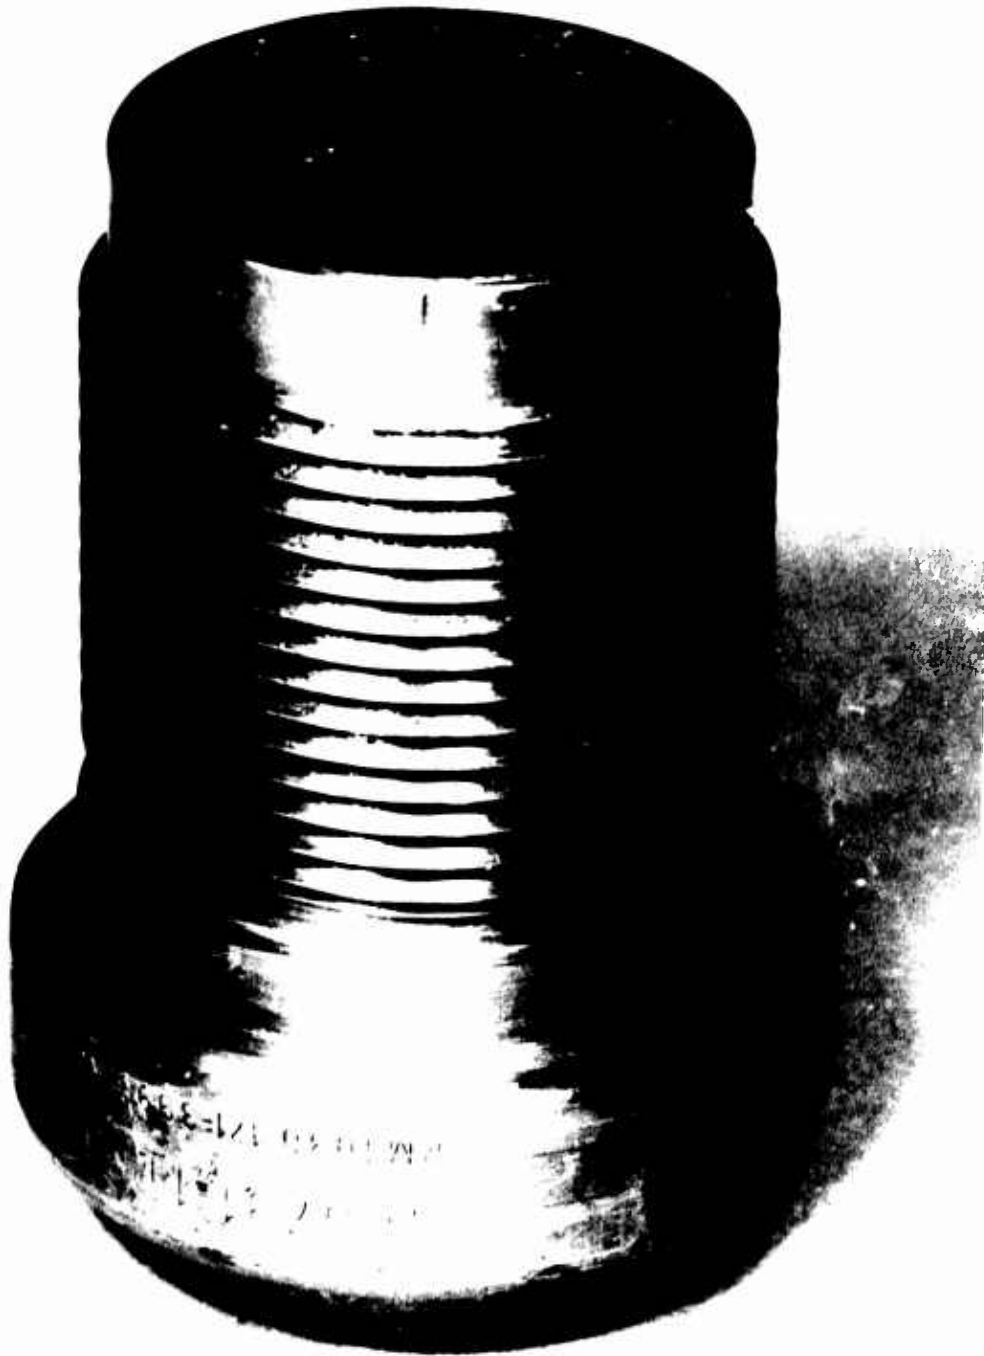
4. An inspection of the failed terminals revealed that the broomed wire rope slipped from the terminals; the epoxy plug, or potting material, was left intact in each terminal, as shown in enclosure (2). During an inspection of the terminals immediately prior to the failures, no epoxy recession nor wire slippage was noted.

5. Investigation of the cause of terminal failure indicates that either the epoxy was improperly cured or the broomed wire was improperly/insufficiently cleaned. The investigation, therefore, was furthered to determine the exact cause.

6. In accordance with the above, a definite cause for the premature failure of the terminals cannot be determined; however, all evidence indicates that incomplete curing of the epoxy terminals was the primary cause.

ENCLOSURE (2) - FAILED EPOXY-POURED TERMINAL (BROOMED WIRE PULLED
COMPLETELY OUT OF TERMINAL--NO EPOXY RECESSION)

7. To eliminate improper curing, special terminal heaters have been designed and procurement initiated. These heaters fit over the terminal and are electrically controlled to maintain a terminal temperature of 115°F before and during post cure. In addition, the "hot tops" removed from all terminals will be tested for hardness by means of a Rockwell Hardness tester to assure that proper post cure has been achieved.
